## Post-Attack Assessment of the First 12 Days of Israeli and U.S. Strikes on Iranian Nuclear Facilities

June 24, 2025

By David Albright and Spencer Faragasso, with the Good ISIS Team

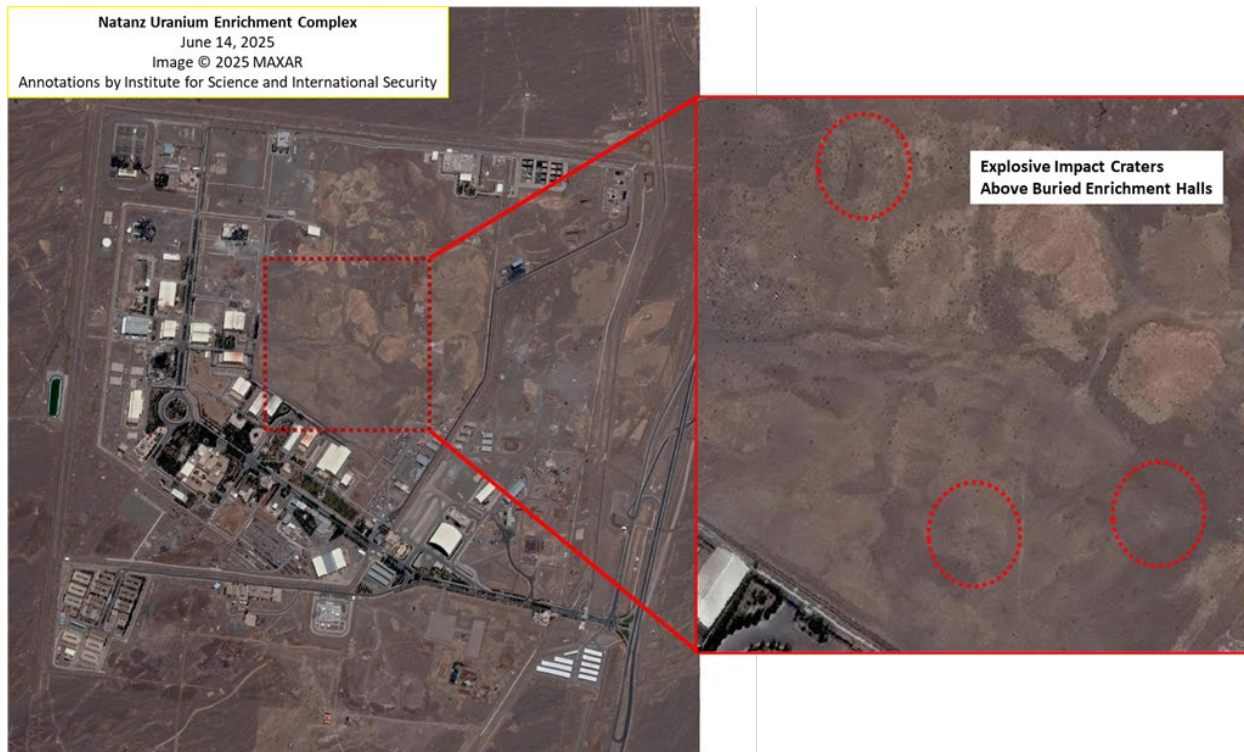
**Figure 1.** An image of the Natanz Uranium Enrichment Complex from June 14, 2025, showing the craters caused by explosives dropped by Israel. In the image on the right, three small impact craters are visible.

On June 13, the Institute reported on the Israeli strikes to Natanz, highlighting the destruction of the Pilot Fuel Enrichment Plant (PFEP) and the onsite electrical infrastructure.<sup>1</sup> The loss of electrical power is likely to have caused damage to the centrifuges in the underground Fuel Enrichment Plant (FEP). A subsequent review of satellite imagery from June 14, 2025, showed two or three small explosive impact craters on the surface over the FEP halls (see Figure 1), leading to a reassessment that substantially more damage likely occurred in the initial attack to the underground enrichment plant. These small craters are consistent with a type of earth or cavity penetrator designed not to detonate on contact like regular weapons but instead to have a shaped-charge that detonates the effective blast forward and not backward. The weapon also tends to be narrower, unlike the MOP. However, because the damage is underground and unseen in satellite imagery, there were questions, even from Israeli officials, how effective the potentially up to three penetrators were. If centrifuges were physically damaged above and beyond uncontrolled shut-down due to the electrical cut-off, then one would have to say the penetrators were successful.

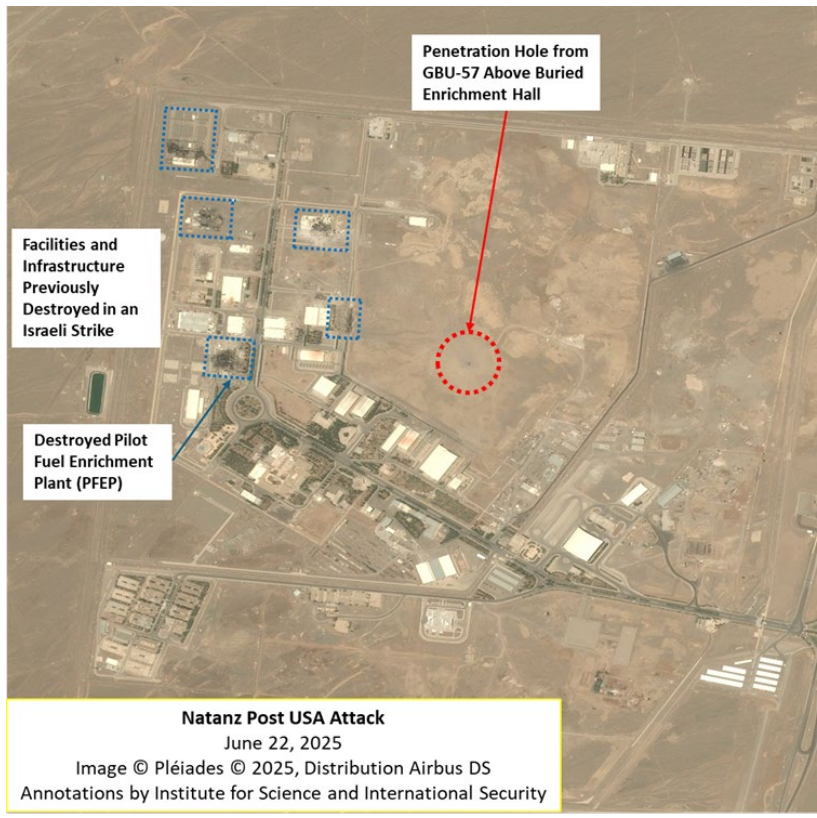
**Figure 2.** Above is an image of the Natanz Uranium Enrichment Complex from June 22, 2025, showing one large crater from one or two MOPs launched by the United States on June 22 (see a closeup below).

The site was attacked again early on June 22, 2025, this time by the United States. Satellite imagery shows at least one penetration hole located above the buried enrichment hall caused by a GBU-57 bunker buster (see Figure 2). It is reported by the U.S. Department of Defense that at least two GBU-57's (MOP) attacked the site, possibly in an attack where one followed the

other through the same penetration hole in a “double tap” strike.<sup>3</sup> As a result, the site is likely destroyed and knocked out of operation. No damage was observed in satellite imagery of the complex being constructed underneath Mt. Kolang Gaz La.

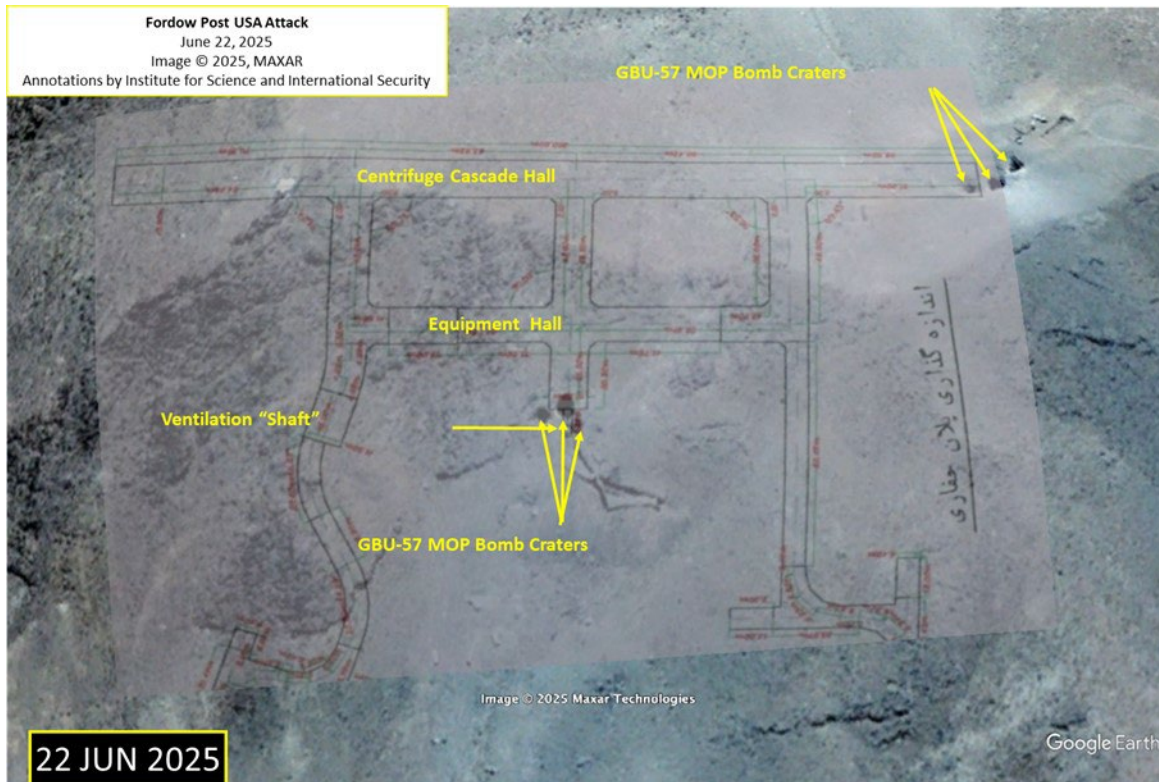
**Figure 5.** An overlay of the underground Fordow schematic with the MOP holes over the ventilation shaft and end of the centrifuge hall.

In a striking attack in the early morning of June 22, the United States dropped twelve MOPs over the deeply buried enrichment halls. High-resolution satellite imagery taken post attack shows two groups of three penetration holes on the mountain above the enrichment halls (see Figure 4). This set of holes are at the location of the ventilation shaft of the underground complex and at the location of previously identified service-related structures that lay above the cascade hall, enabling easier pathways for the MOPS to the deeply buried halls (see Figure 5). As a result, the facility is likely severely damaged or destroyed.

These Institute generated graphics providing our best estimate of the likely relationship of the surface cratering from 12 GBU-57 MOP bunker buster bombs to the deeply buried underground gas centrifuge complex at Fordow. We were able to orient and scale plot plans captured by

Israel and made available publicly in previous Institute reporting as overlays on Google Earth together with historical imagery and the June 22, 2025, imagery that revealed the post attack cratering. It appears that the bombing was precisely targeted to concentrate on two likely points of vulnerability evident from both the available plot plans and the complex's features observed during construction on historical satellite imagery publicly available on Google Earth. The first point target is what can generally be termed as a ventilation "shaft" but is likely a more elaborate structure, which connects subsurface with a central hallway leading to the two main underground halls shown in the plot plan housing both equipment and centrifuges. The second point target is located on the other side of the mountain ridge. Our overlay indicates that the bombs precisely struck an unknown surface service structure located directly above the south end of the centrifuge cascade hall. This service structure was only visible for a short time in late 2009 during its installation, just prior to being earth covered to conceal its presence. Such point targeting not only completely destroyed that surface structure but was likely intended to focus at depth on the south end of centrifuge cascade hall, which, once breached, would use the hall's long side walls to channel the blast wave through the entire length of centrifuge cascade hall completely destroying all of the installed and otherwise operational centrifuges. Interestingly, the bomb blast waves that would have been generated down the two halls from these two points of attack run perpendicular to one another, further increasing the likelihood of maximum damage and destruction. Figures 5 and 6 show slides from the graphic slideshow and the slide show is available at: <https://x.com/TheGoodISIS/status/1937547337917669404>.

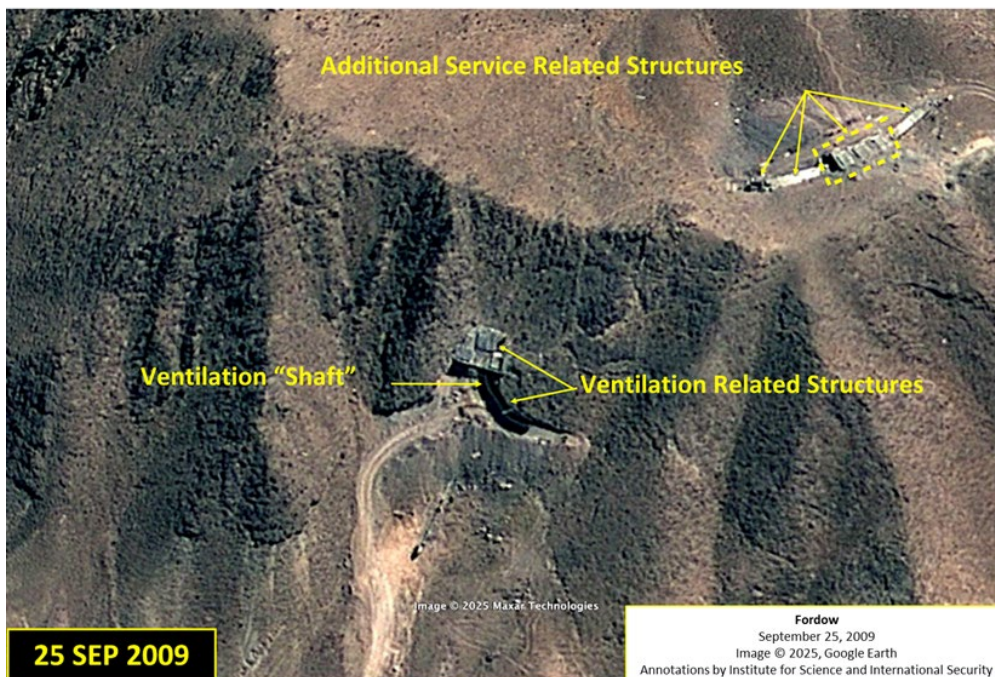
**Figure 6.** A 2009 image of construction associated with the ventilation shaft (top image). The bottom image is a composite image of the top image with the image showing the location of the MOP entry holes, showing a close fit between the three holes and the ventilation area and additional service-related structures on the surface.

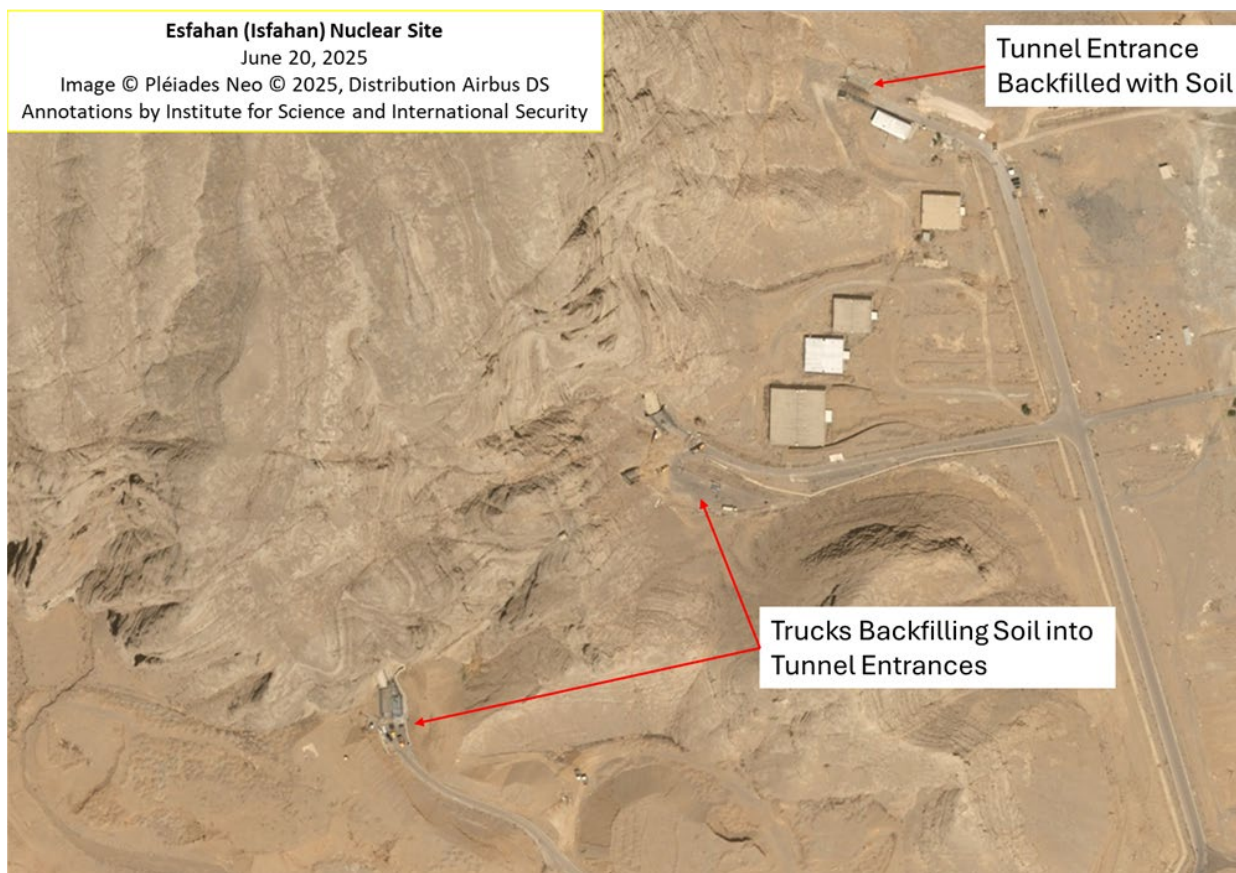
**Figure 9.** A satellite image taken on June 20 before the United States attacked the site. The image shows the Iranians backfilling the tunnel entrances.

The next night, on June 22, the United States attacked the site with Tomahawk cruise missiles launched from a submarine, damaging additional buildings and the associated tunnel complex (see Figure 8). Notably, the main uranium conversion facility that converts natural uranium into uranium hexafluoride was severely damaged. Uranium hexafluoride is the form of uranium entered into gas centrifuges. Tunnel entrances leading to an underground complex just north of the main Esfahan complex were also struck during the attack. All four tunnel entrances appear to have collapsed. The IAEA also assessed that “extensive damage” was done to the tunnel entrances. Similarly to the tunnel entrances leading into Fordow, satellite imagery from June 20 shows the Iranians preparing for the attack by backfilling the tunnels with soil (see Figure 9).

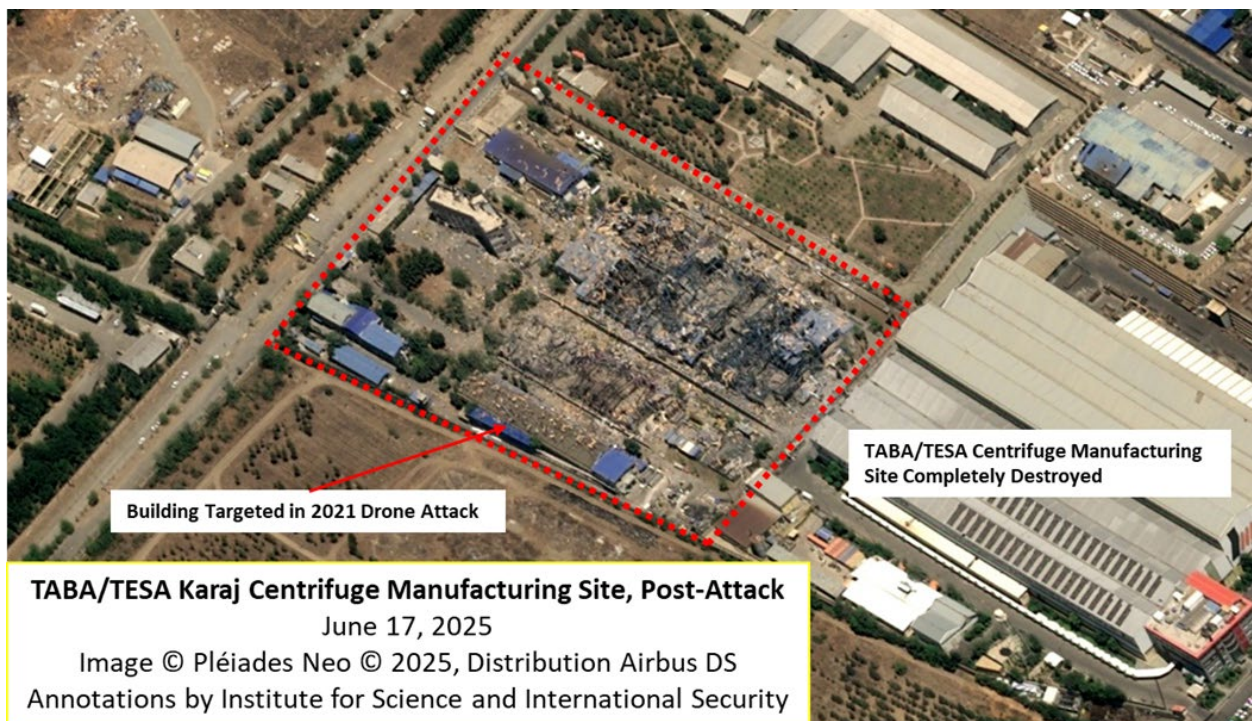
**Figure 10.** A post-attack satellite image of the Karaj Centrifuge Manufacturing site. The complex was nearly completely destroyed in the attack.

Satellite imagery from June 17, 2025, shows that nearly the entire complex was destroyed in airstrikes (see Figure 10). The two large manufacturing buildings, which were previously identified as fabricating gas centrifuge parts were completely demolished, spreading debris throughout the complex. The office building adjacent to the manufacturing buildings appears to also be damaged by the explosions. The building originally targeted in June 2021 is still standing, although it is also damaged by the explosion.

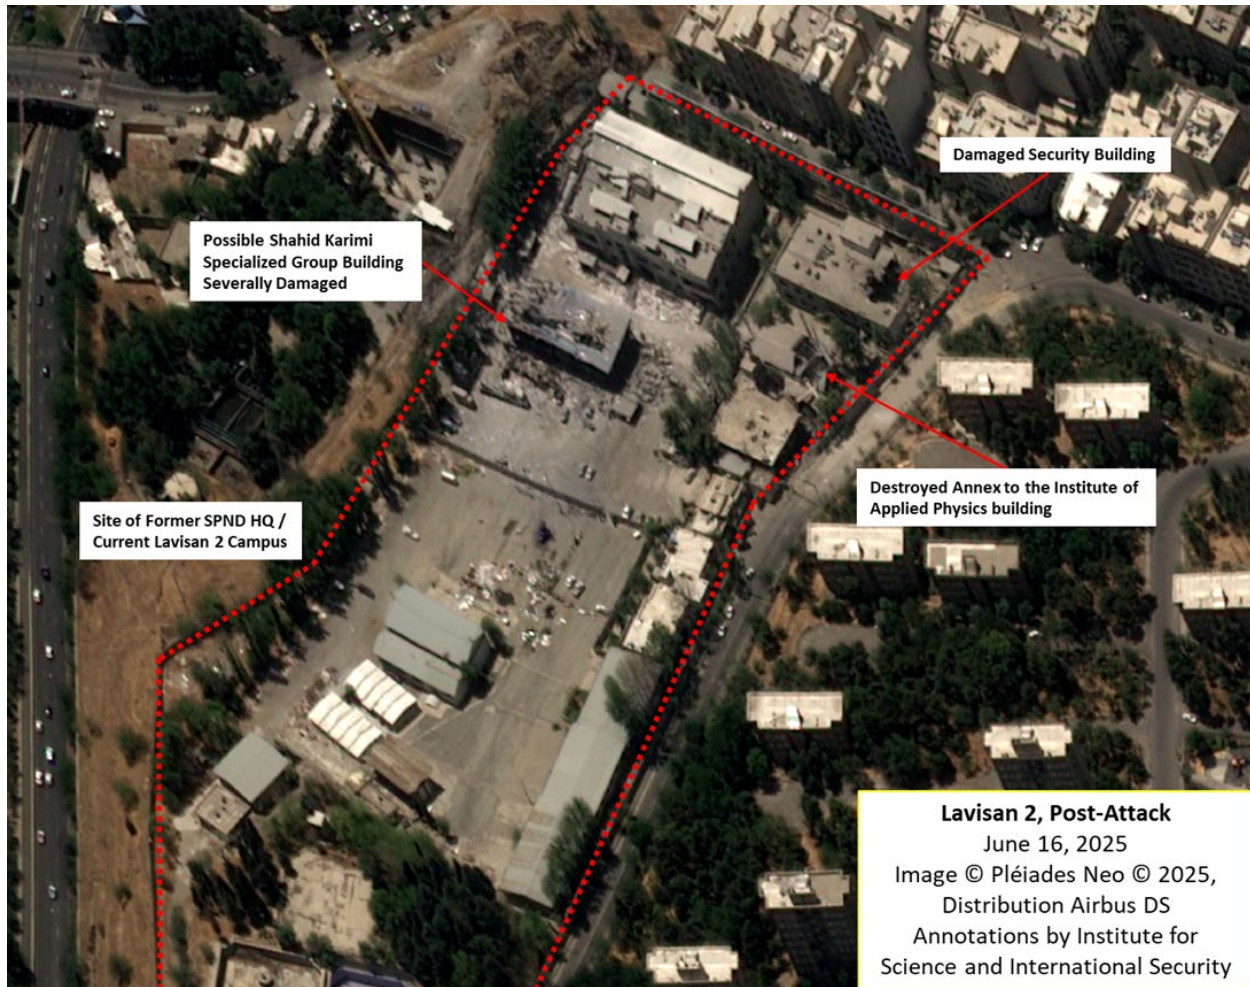
**Figure 11.** A high-resolution satellite image of the Lavisan 2 campus post-attack, taken on June 16, 2025.

The campus was targeted by Israel, destroying several buildings (see Figure 11). Satellite imagery from June 16, 2025, shows damage to several buildings, including the onsite security building and the building housing Shahid Karimi Group. An annex to the building housing the Institute of Applied Physics was completely destroyed. Debris is scattered throughout the campus.

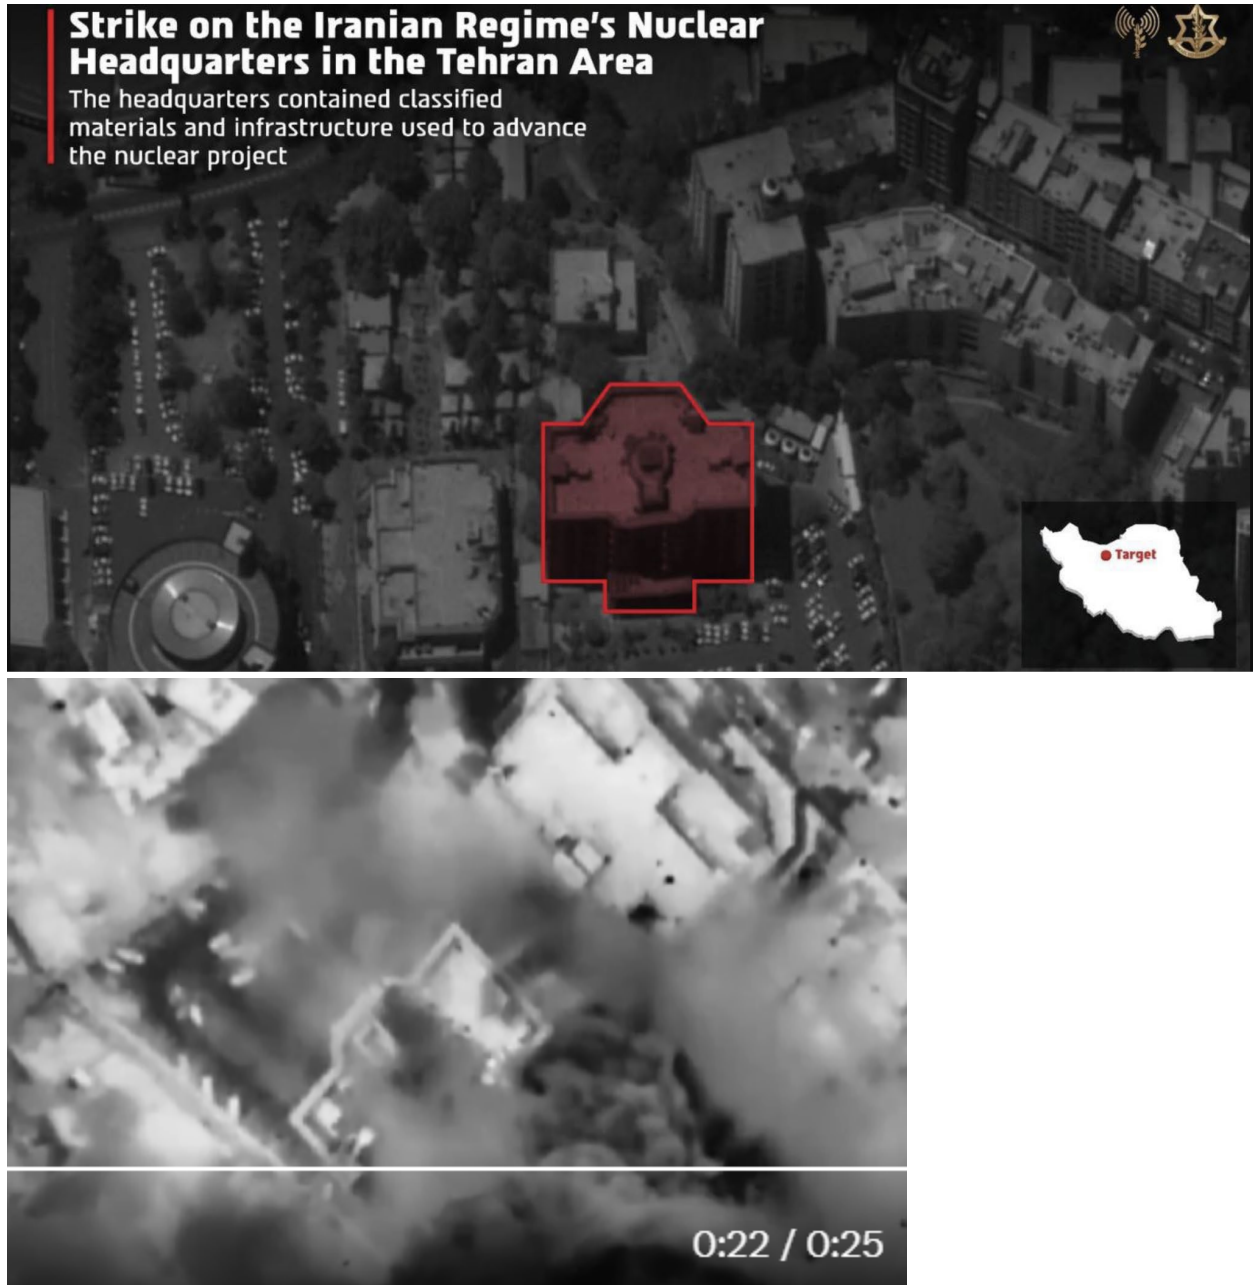
**Figure 12.** Above is a graphic released by the Israeli Military highlighting the targeting of the new SPND HQ. Below is a screenshot of the video released by Israel of the SPND building when it was attacked.

SPND moved to a different headquarters in 2013, just one and a half kilometers from its previous location at the Lavisan 2 campus. This building was never visited by the IAEA. According to a graphic released by Israel and videos posted on X, the building appears to have been targeted with airstrikes on June 15 and June 20, 2025 (see Figure 12).<sup>8</sup> A satellite image from June 18, 2025, shows the building still standing (see Figure 13). The video posted on X of the airstrike suggests a large amount of internal damage to the building and its surrounding complex with rubble visible at the rear of the building. We are also aware that on other satellite imagery obtained the day after the attack, several trucks were present in the parking area near the entrance to the headquarters, suggesting that materials such as documentation

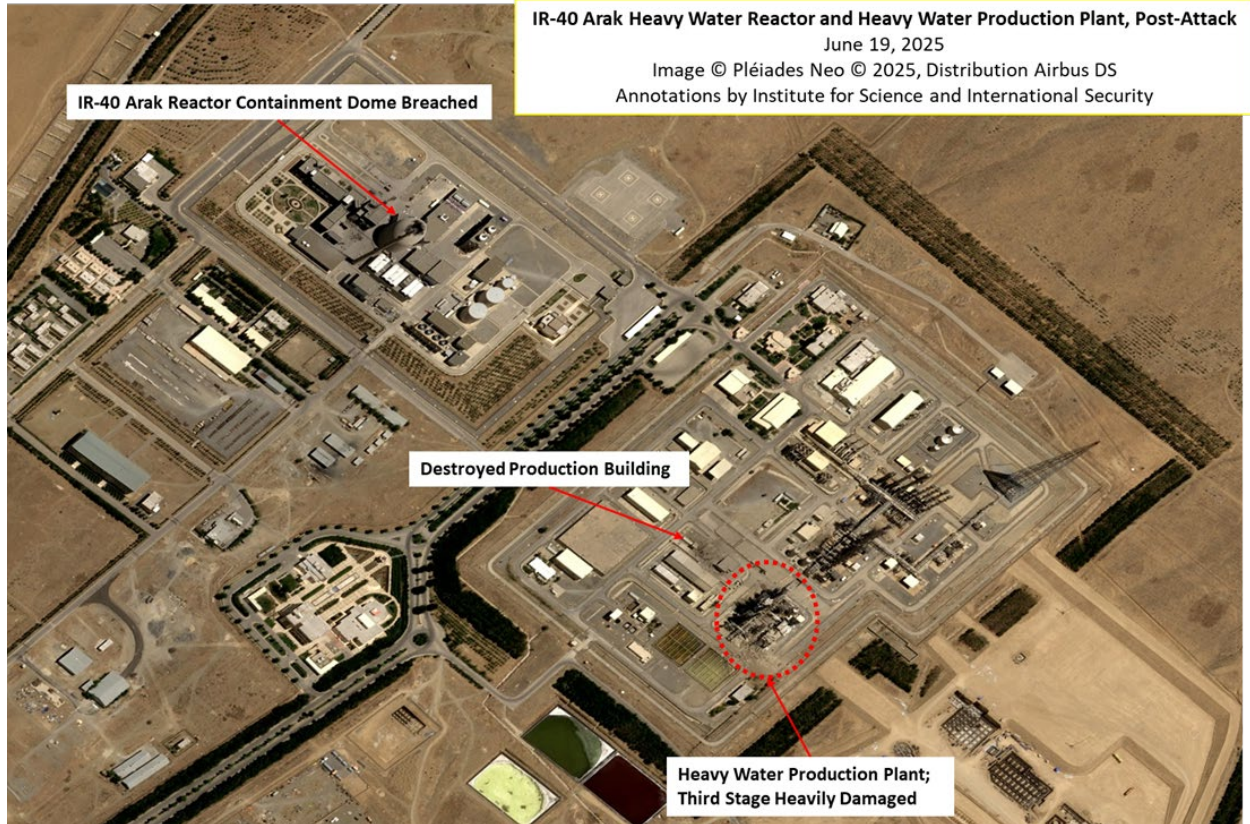
**Figure 16.** An overview satellite image from June 19, 2025, of the damage done to the IR-40 Arak Heavy Water Reactor Complex and Heavy Water Production Plant.

Satellite imagery from June 19, 2025, shows the containment dome of the IR-40 reactor breached, likely causing a large explosion on the inside of the reactor (see Figure 16, 17, and 18). The strike has rendered the reactor inoperable; however it is unclear if the reactor pool itself suffered compromising damage. Debris can be seen on the ground surrounding the reactor. The nearby Heavy Water Production Plant was also targeted. The final third stage of the heavy water production plant has been severely damaged in the airstrike, rendering the plant inoperable, at least temporarily. The remainder of the heavy water plant appears intact.

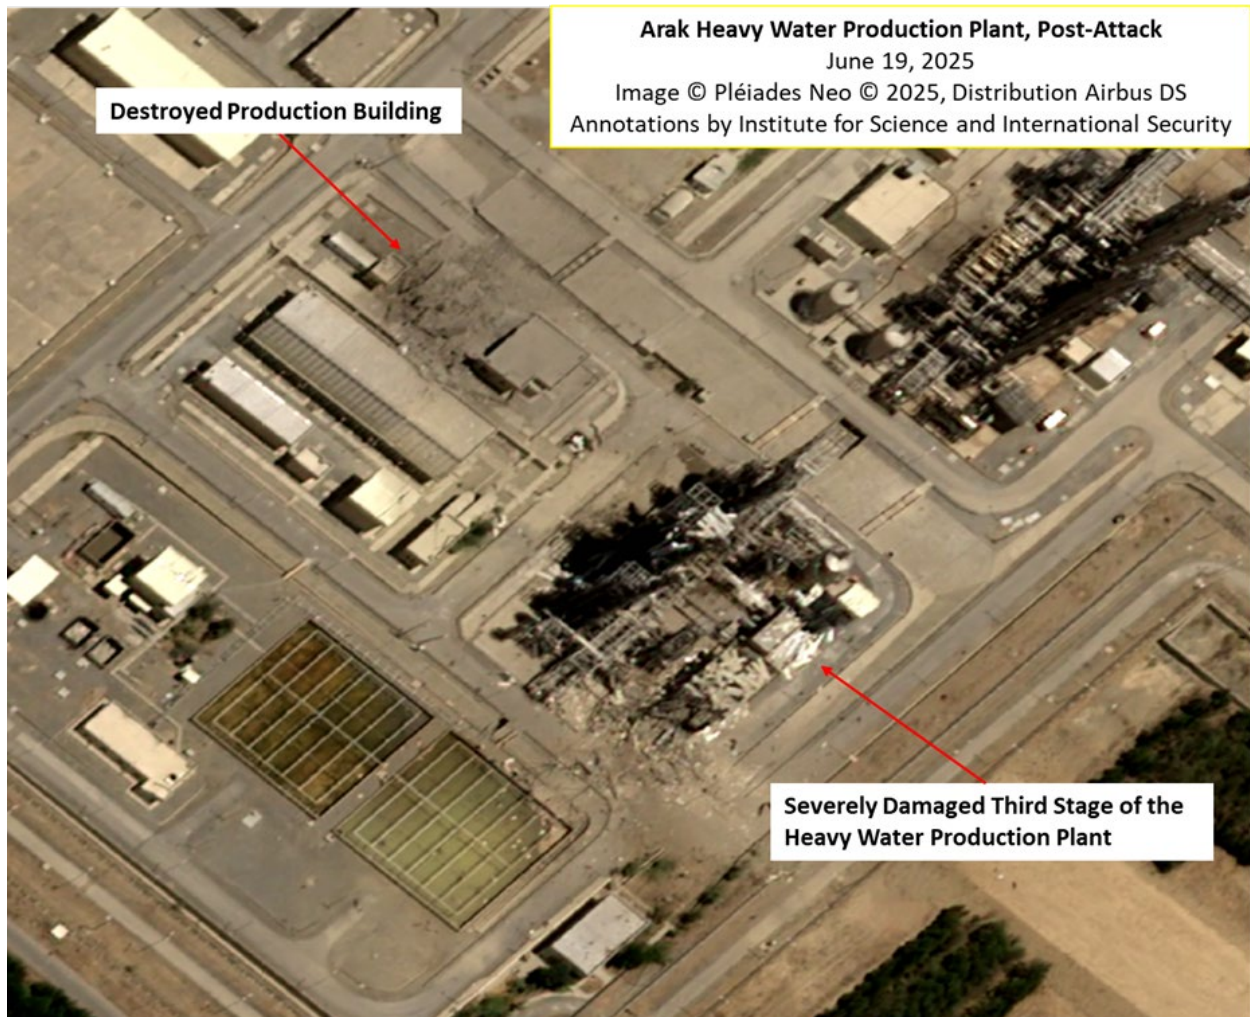
**Figure 18.** Three satellite images from June 19, 2025, of the damage done to the IR-40 Arak Heavy Water Reactor and adjacent Heavy Water Production Plant.
